Escalator and Moving Walk Safety

European Recommendations
for Safety Improvements of
Escalators and Moving Walks in Operation

This document was prepared by experts of the Escalators and Moving Walks Work Group of ELA in 2010.

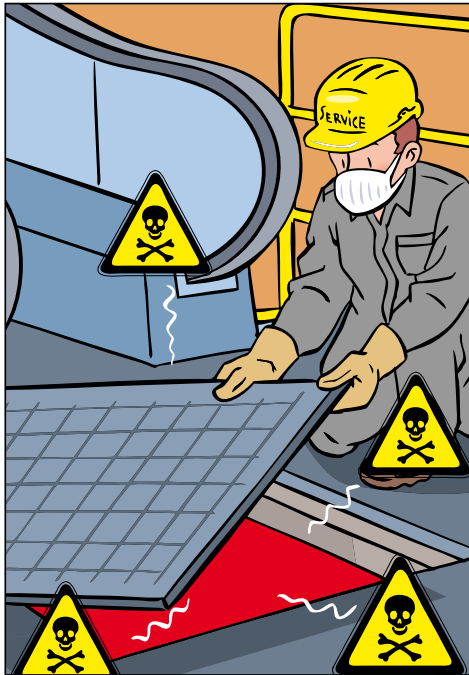
1 Effects of harmful materials

Harmful materials such as asbestos are present in brake linings, contactor shields or claddings. There is a risk of asbestos fibre being released to the air whenever the brake is applied.

Remove harmful materials subject to disintegration (e.g., replace brake lining material) and attach a warning label stating that maintenance work must not be performed unless the harmful materials (which may include the cladding) have been removed.

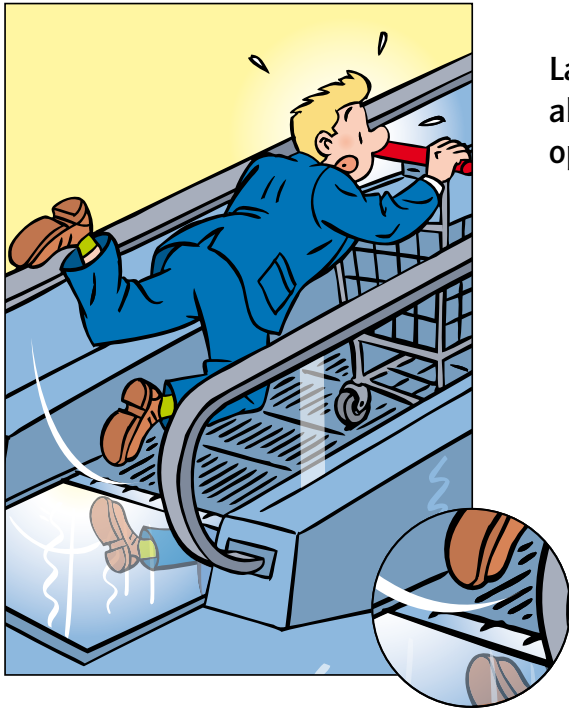
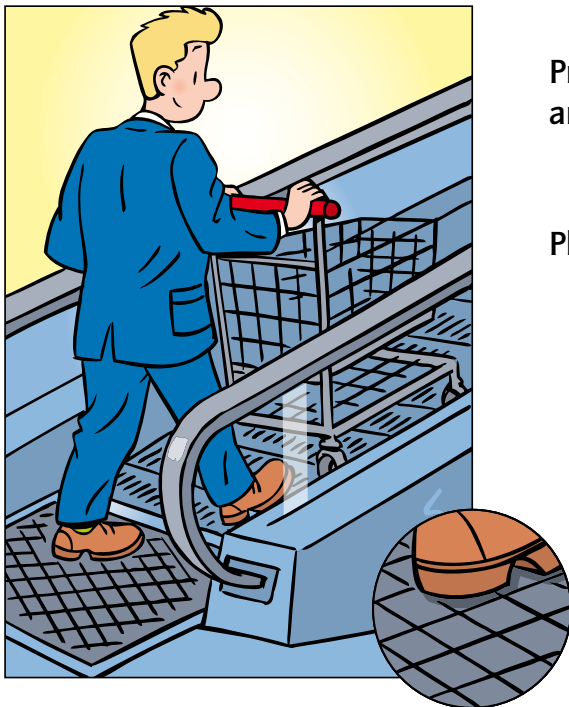
Slipping on steps/pallets/belt and on landings **2**

Landing areas and tread surfaces may not always provide a secure foothold given the operating and environmental conditions.

Provide secure foothold on tread surfaces and landing areas.

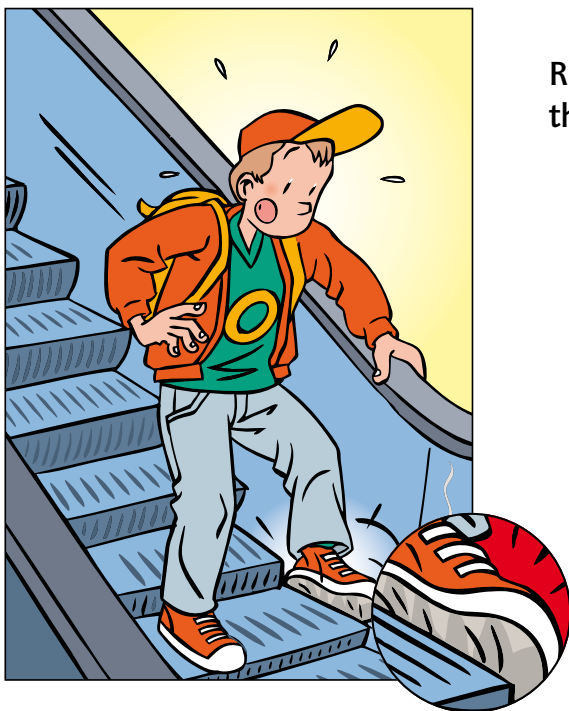
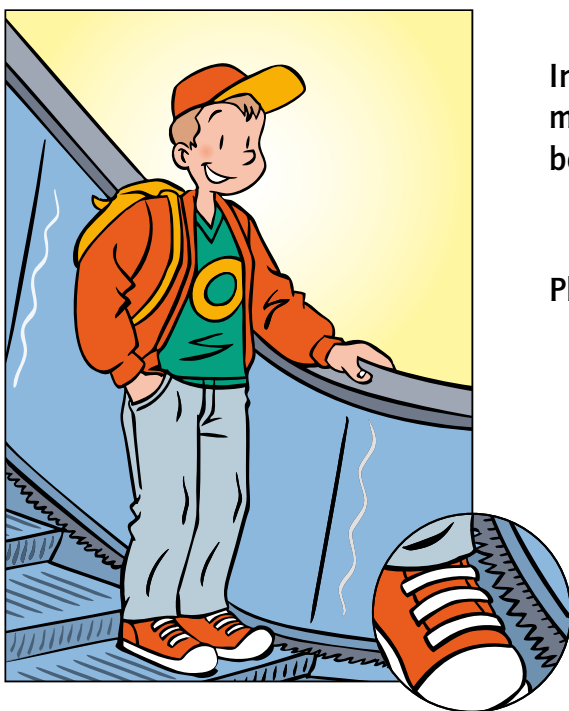
3 Entrapment between skirting and steps

Risk of entrapment due to a gap between the steps and the skirting.

Install skirt deflectors on escalators to minimise the possibility of entrapment between skirting and steps.

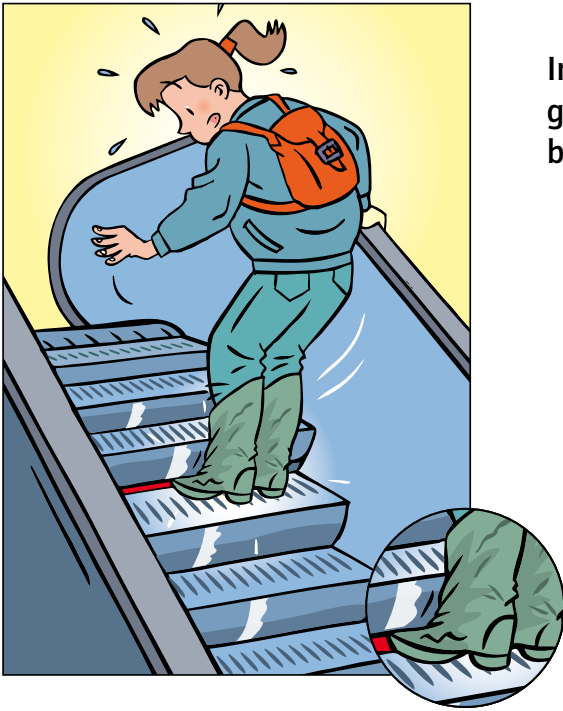
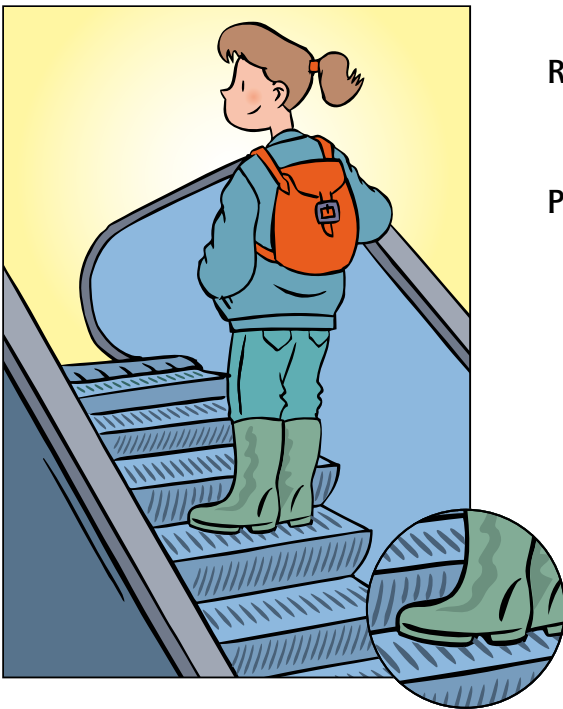
Entrapment between steps or pallets 4

Increased risk of objects/extremities getting trapped due to excessive gaps between steps or pallets.

Reduce gap to an acceptable level.

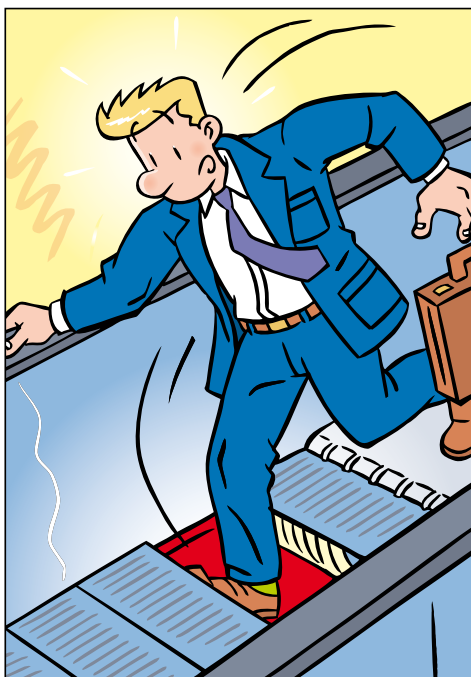
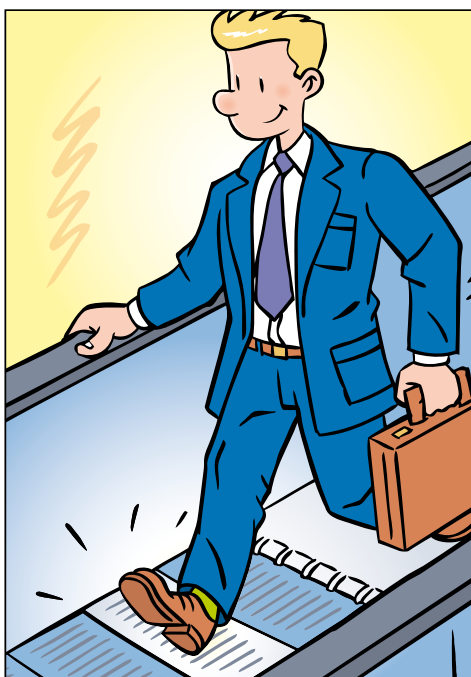
5 Missing steps or pallets

Missing steps or pallets can have severe or even lethal consequences.

Install at least two missing-step/pallet monitoring devices: one in the area of the drive station, the other in the area of the return station.

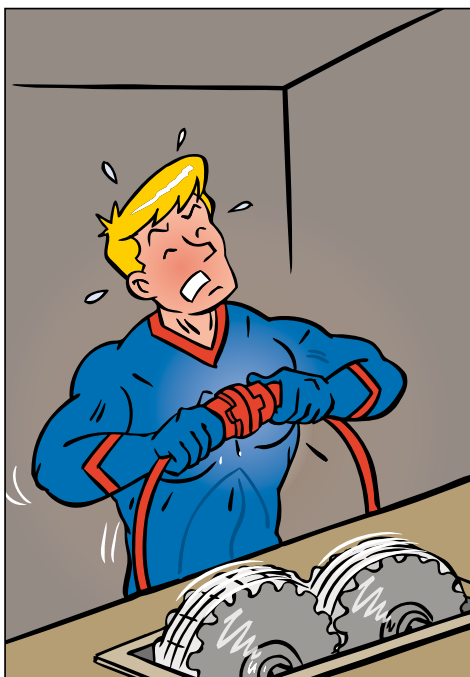
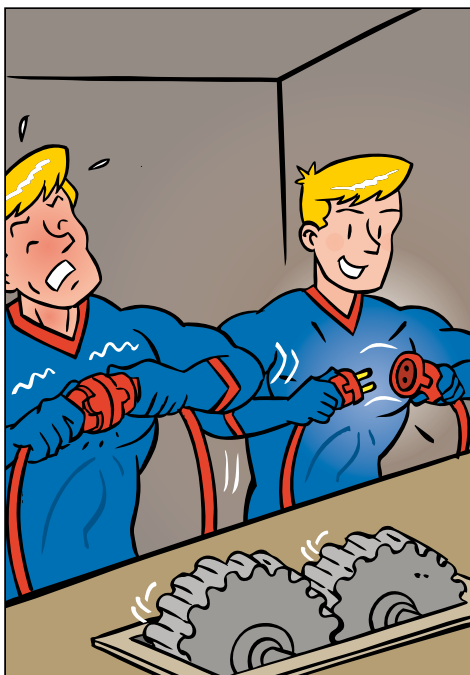
No stopping or re-starting due to absence of a second independent main contactor **6**

For stopping and restarting requirements to be met, there should be two independent electrical devices. If there is only one contactor, its failure may lead to hazardous situations.

Install a second independent device for interrupting the power supply.

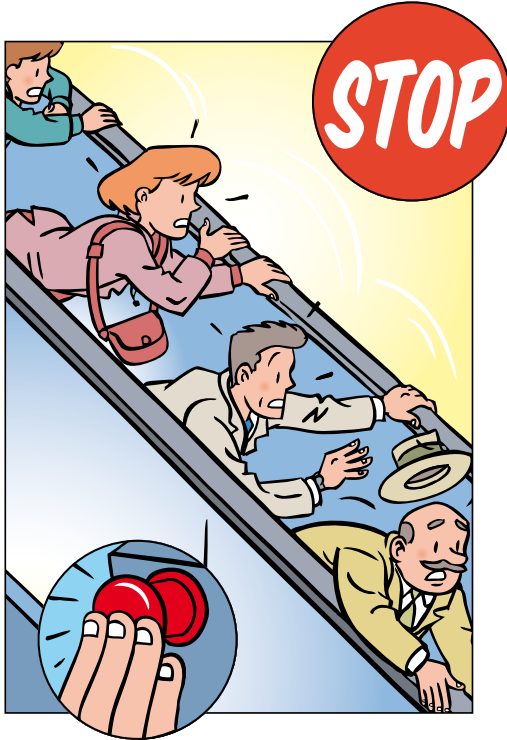
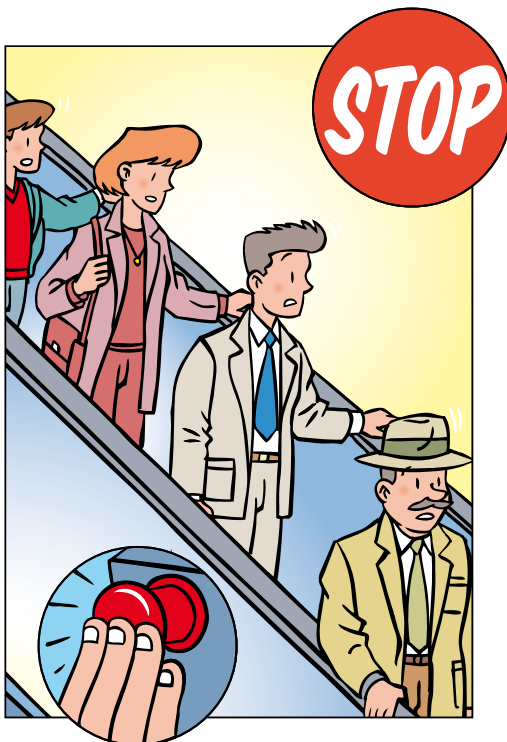
7 Falling due to stopping distance being too short

If the escalator or moving walk is stopped unexpectedly, people may fall if the stopping distance is too short.

Provide a brake system that meets the defined stopping distance requirements.

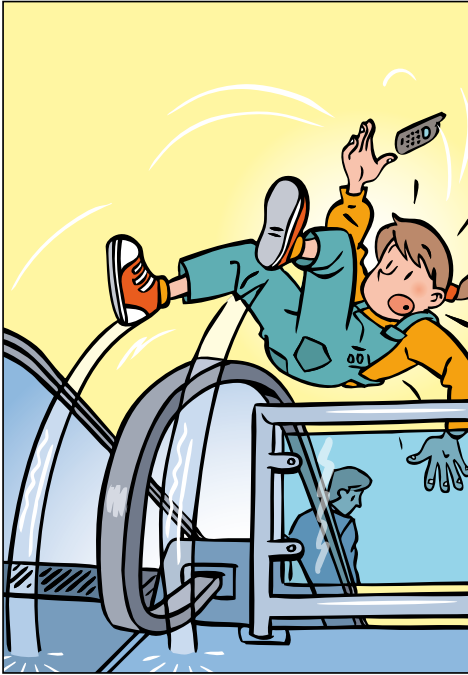
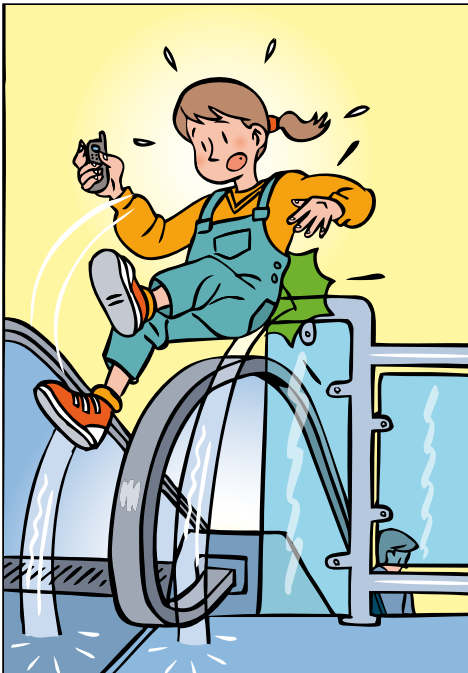
Falling from a landing 8

At a landing, persons may come into contact with the outer edge of the handrail and as a result fall from the landing, e.g., by toppling over the balustrade.

Increase the height of the building structure supporting the fixed balustrade in the hazardous area.

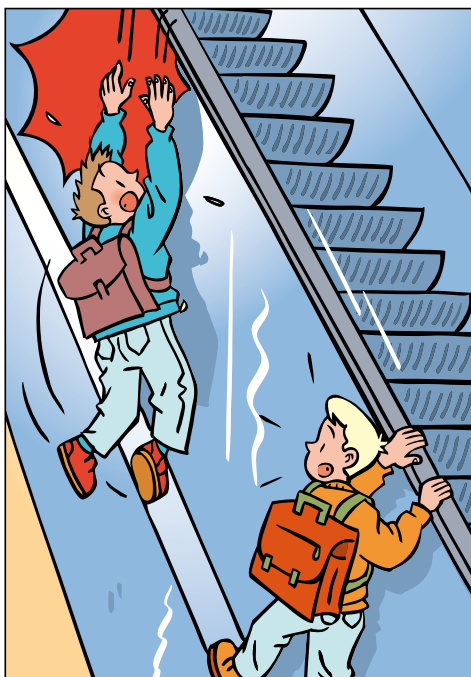
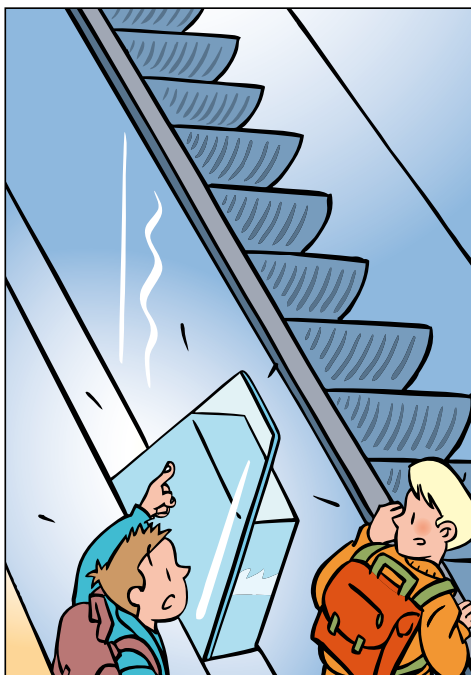
9 Climbing the balustrades

Climbing the balustrades may result in serious injury.

Provide anti-climbing devices on outer deckings.

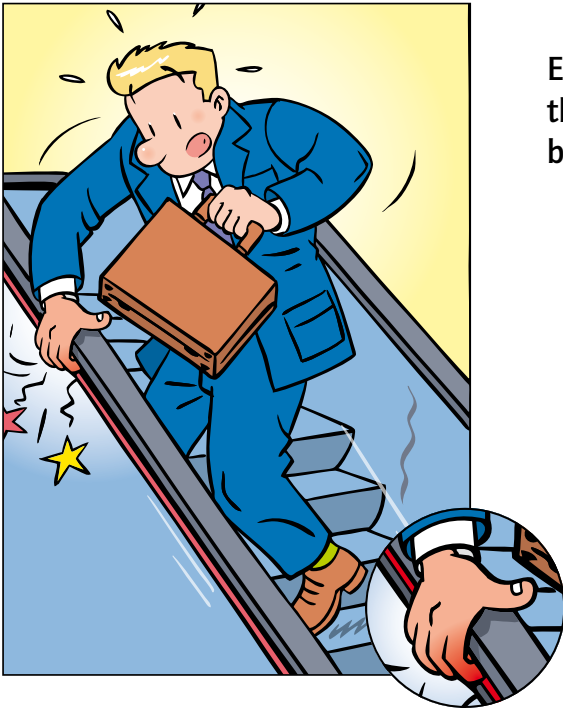
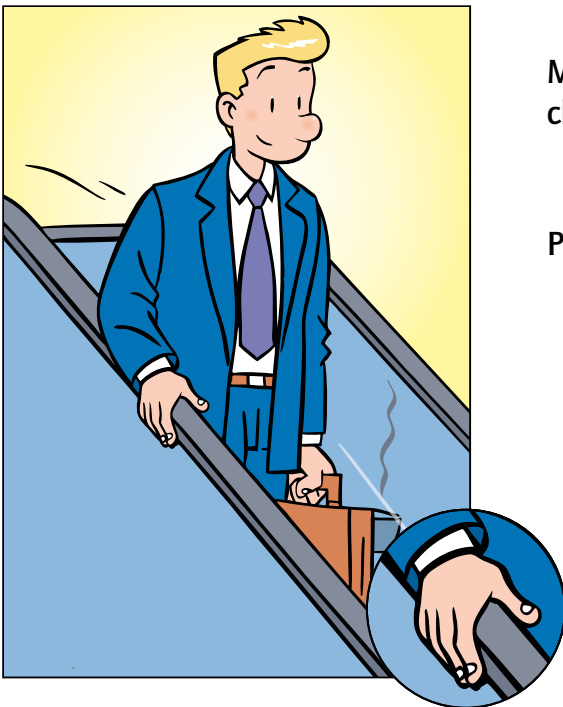
Crushing of fingers between handrail and balustrade 10

Excessive gaps between the handrail and the balustrade profile can cause fingers to become trapped.

Modify components to achieve acceptable clearances.

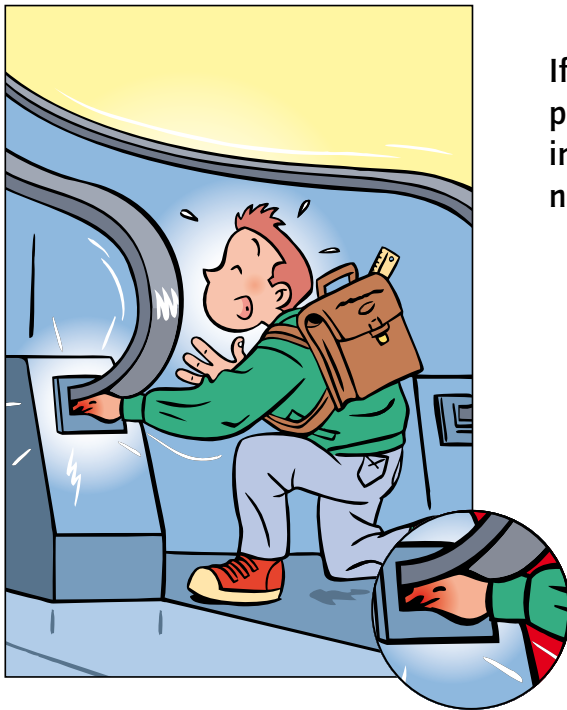
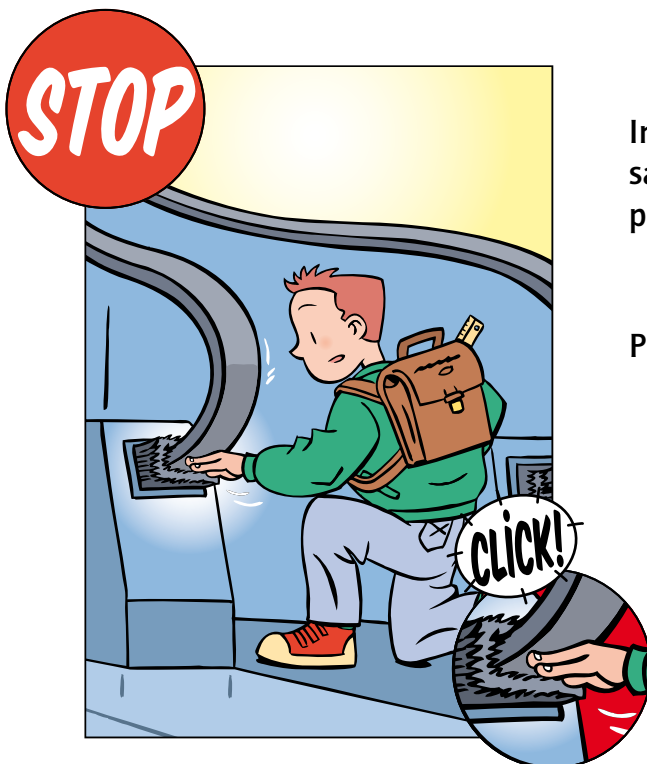
11 Entrapment at handrail entry points

If there are no guards at the handrail entry points, fingers may be trapped, resulting in injury if the escalator or moving walk does not stop.

Install adequate guards and electrical safety devices at the handrail entry points.

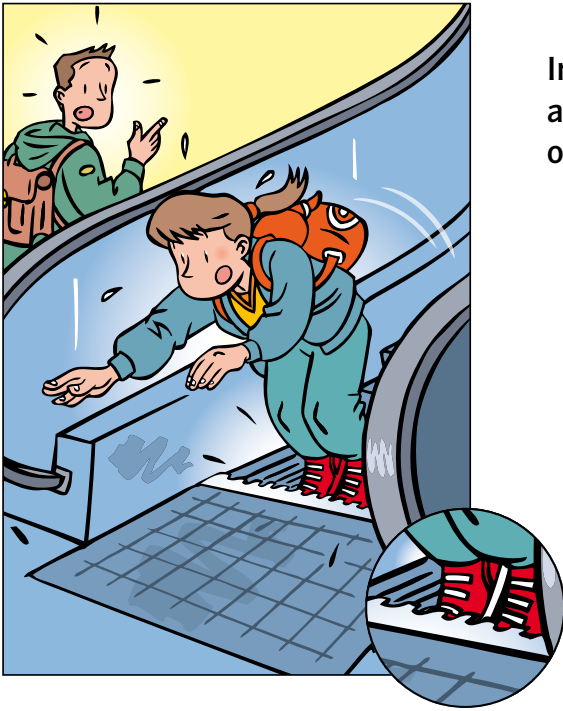
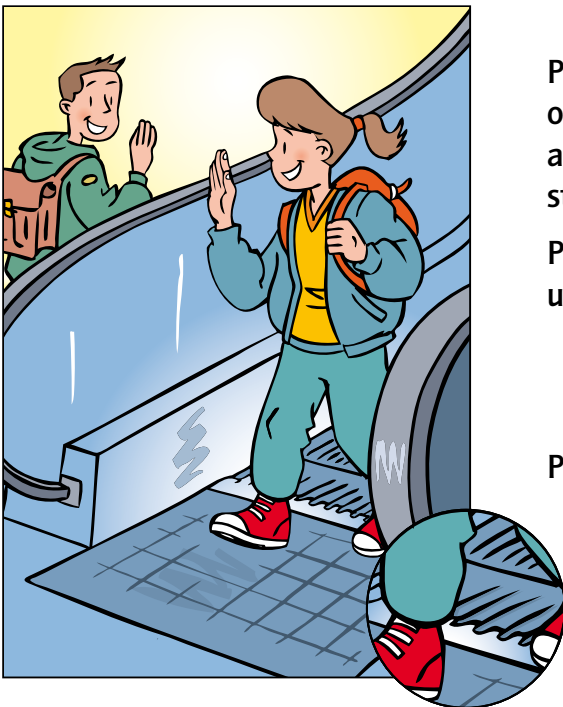
Entrapment between combs and steps/pallets/belt 12

Insufficient meshing between the combs and the tread surfaces of the steps/pallets or the belt may result in entrapment.

Provide combs designed so that if a foreign object becomes trapped, they either deflect and remain in mesh with the grooves of the steps, pallets or belt, or break.

Provide an electrical contact that stops the unit if an object impacts the combs.

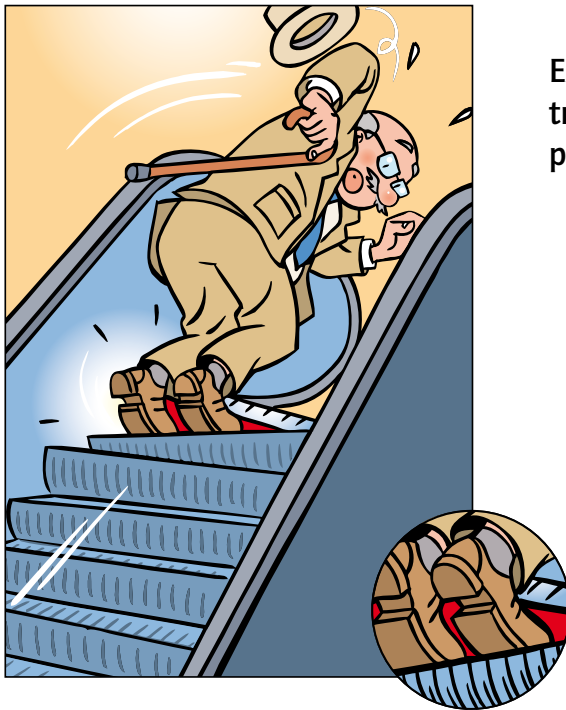
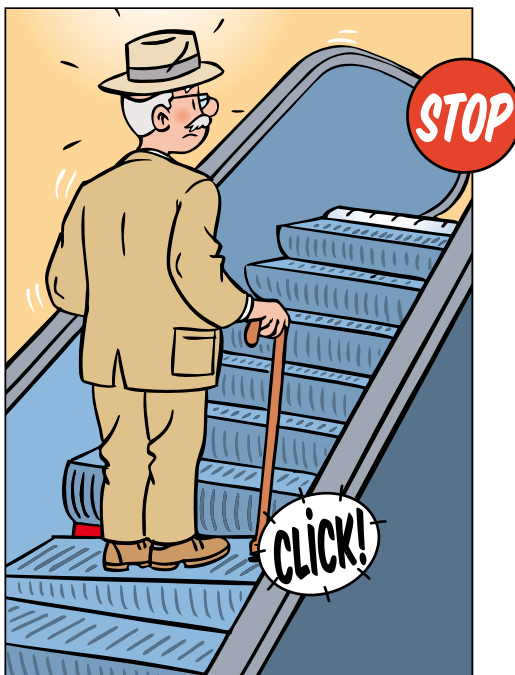
13 Entrapment due to sagging step/pallet

Excessive distance between combs and tread surfaces due to sagging steps/pallets may result in entrapment.

Install an electrical safety device at a proper distance before the comb intersection line.

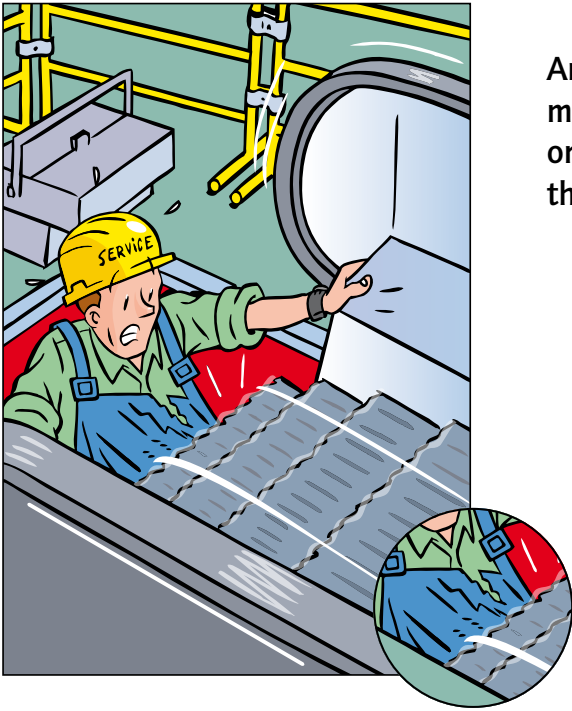
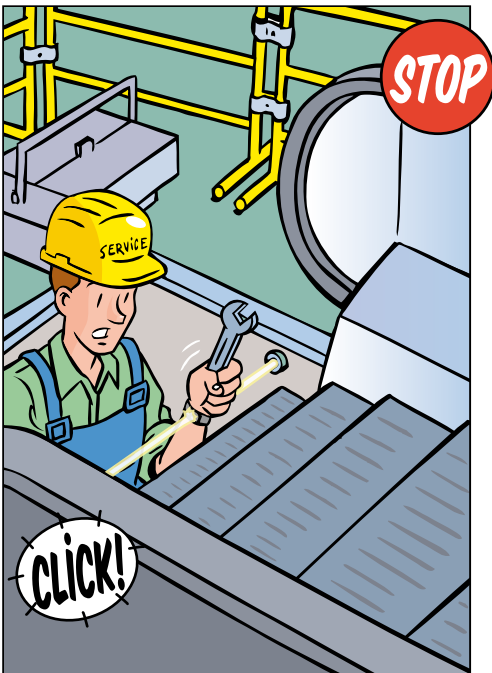
Insufficient space in working area 14

An authorised technician performing maintenance or repair work in the drive or return station could become trapped if there is insufficient space.

Provide a device (e.g., light beam) to detect persons approaching the hazardous area at the drive or return station.

Normal and inspection operating modes should be interrupted if a person is detected.

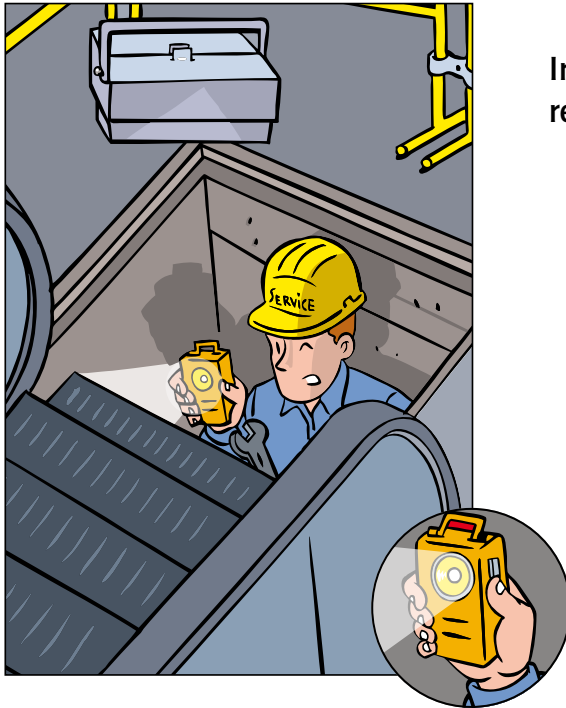
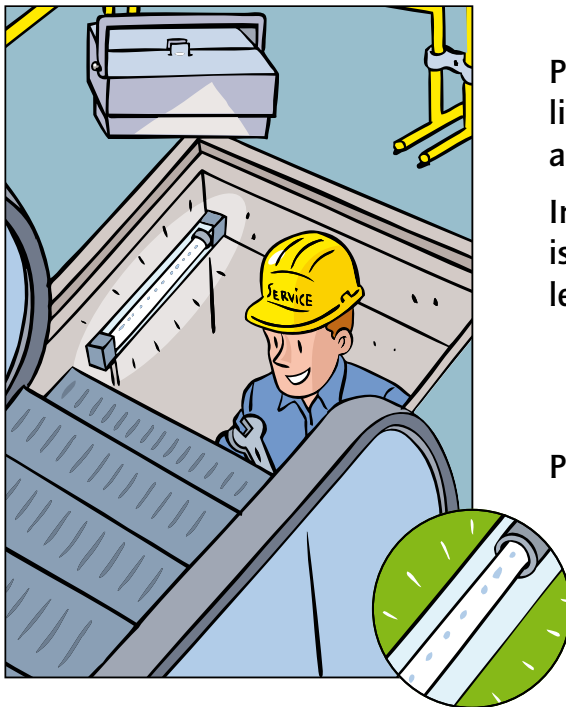
15 Inadequate lighting in working area and surroundings

Inadequate or non-compliant lighting can result in unsafe working conditions.

Provide one or more socket outlets for lighting in the drive and return stations and machinery spaces inside the truss.

In areas where maintenance or repair work is performed, the light intensity must be at least 200 lux.

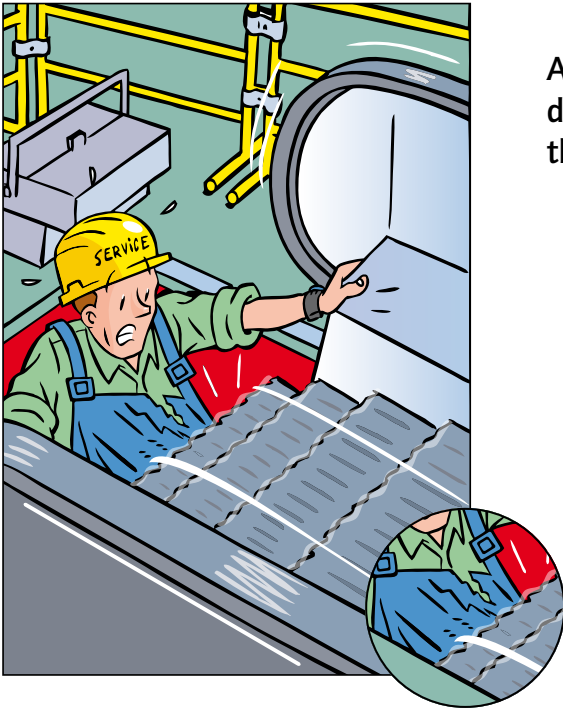
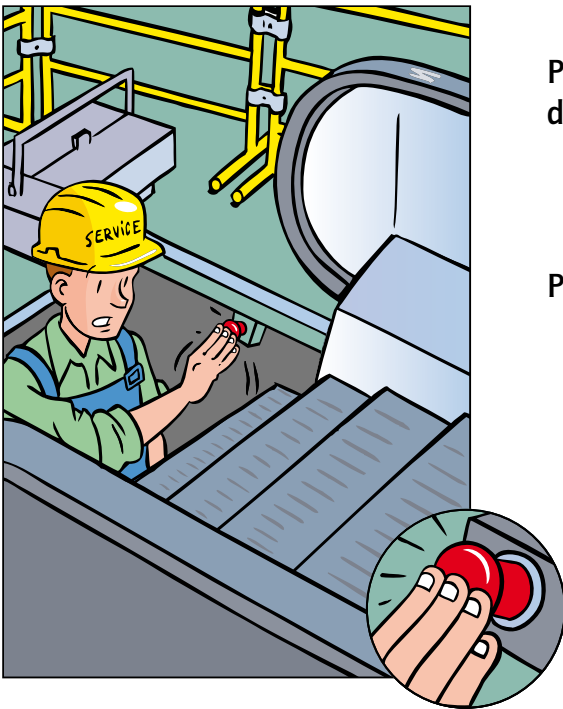
No emergency stop switch in working area 16

An authorised technician working in the drive or return station could be injured if there is no stop switch.

Provide emergency stop switches in the drive and return stations.

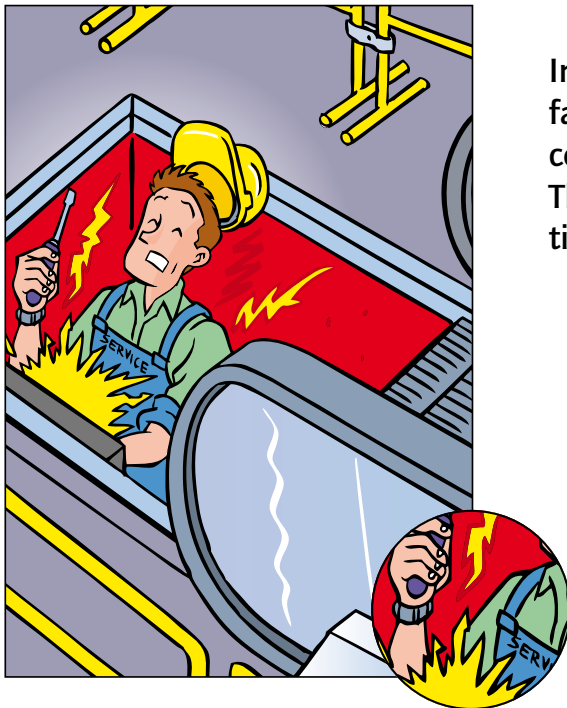
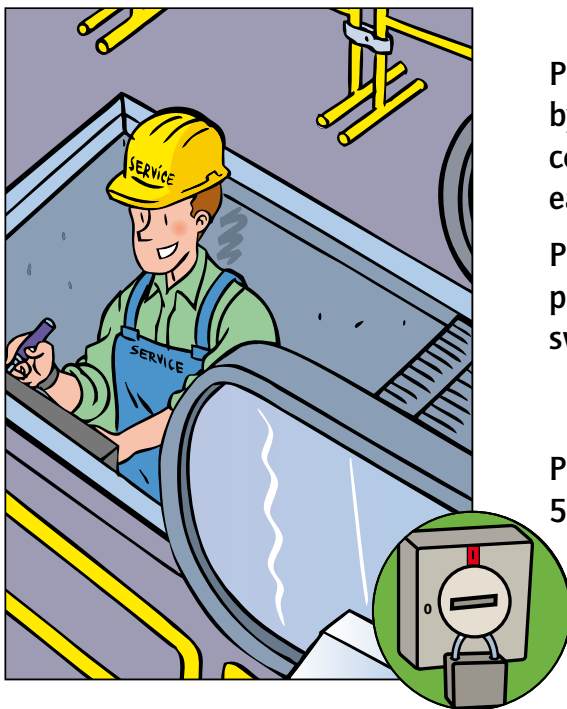
17 Electric shock due to contact with live parts

Insufficient insulation and/or insulation failure that causes a person to come into contact with live current is unacceptable. This also includes unsafe working conditions due to the absence of a main switch.

Provide protection against electric shock by adequately insulating live electrical components and by providing adequate earthing.

Protect the unit against unintentional powering up by installing a lockable main switch.

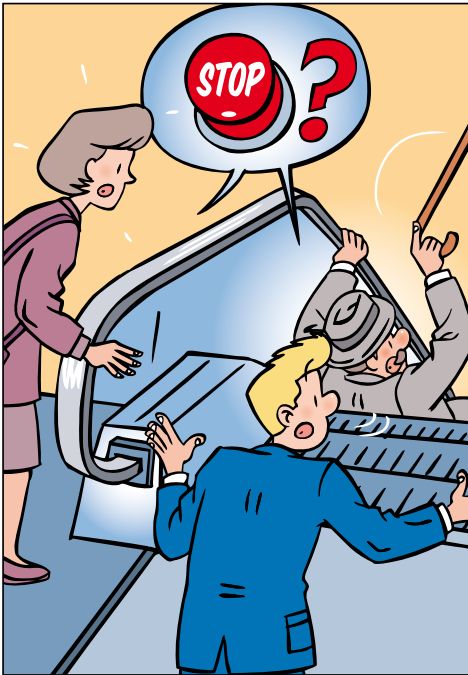
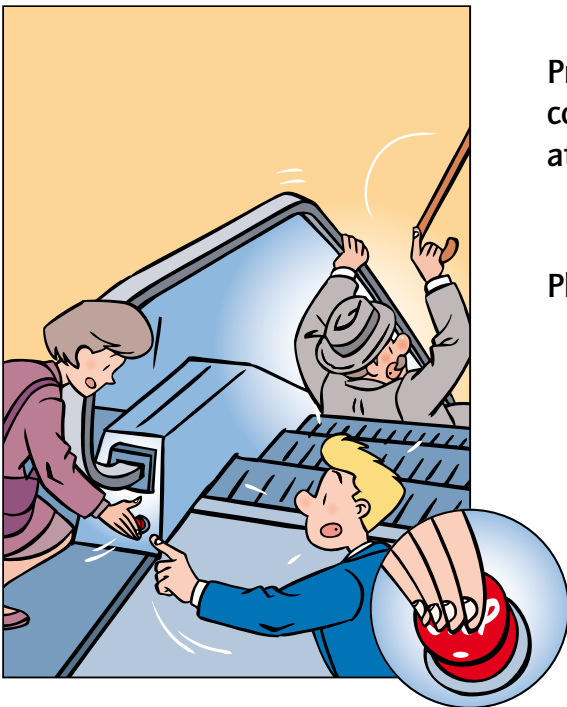
Injury due to absence of an emergency stop switch 18

If there is no switch with which a user can stop the escalator or moving walk in an emergency, injuries may result.

Provide emergency stop switches in conspicuous and easily reachable positions at or near the landings.

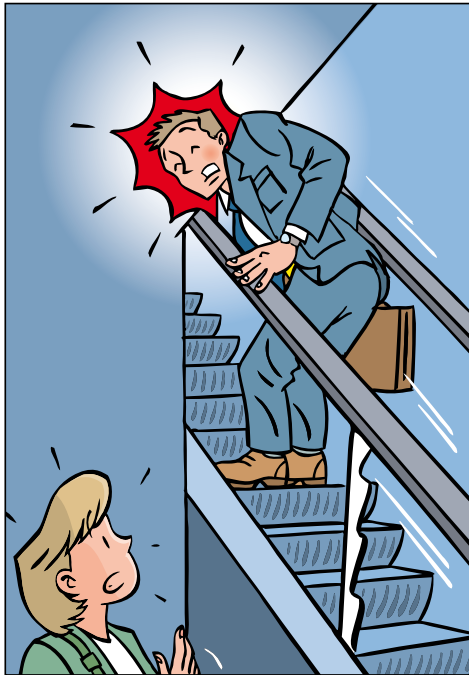
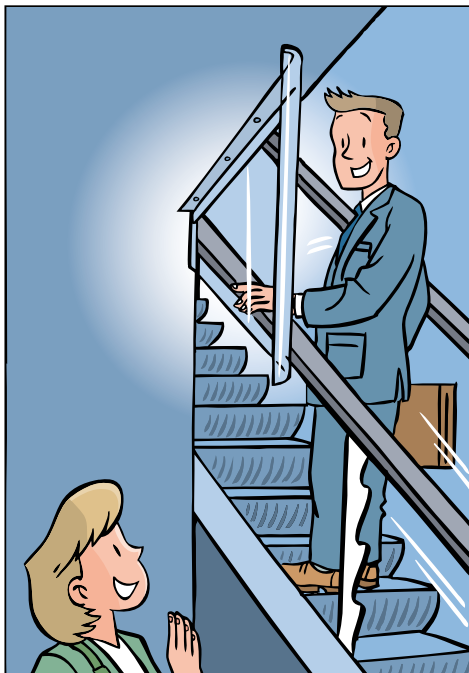
19 Collision with building structures

Building obstacles such as walls, pillars, floor intersections or criss-cross arrangements of escalators/moving walks can cause injuries.

Provide correctly positioned deflectors.

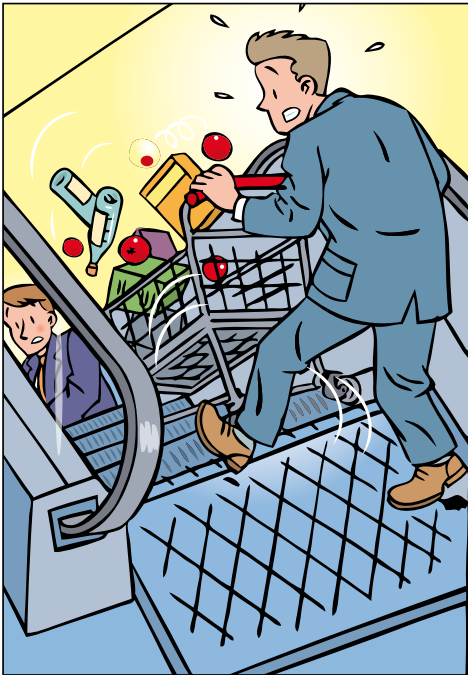
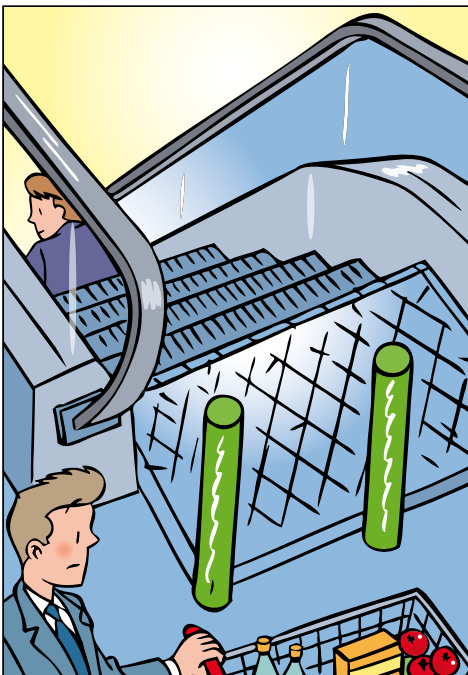
Improper use of an escalator to move a shopping or baggage cart 20

If a person deliberately misuses an escalator by using it to move a shopping or baggage cart, this may put other people at risk.

Provide barriers to prevent access with shopping or baggage carts. This keeps the space free for appropriate use.
