Safety of Existing Lifts

Introduction to the SNEL application (EN 81-80)

Introduction to the SNEL application
(EN 81-80:2019)

September 2020

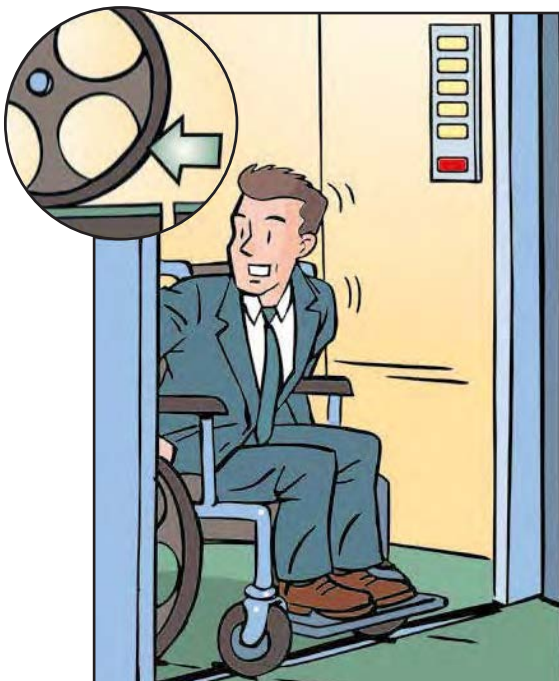
Risk reduction measures

New controllers, regulated drive-systems and re-levelling devices, make sure that the lift self-corrects and is always at the right level. The stopping accuracy of the car shall be ± 10 mm, a levelling accuracy of ± 20 mm shall be maintained. If, during e.g. loading and unloading phases, the value of 20 mm is exceeded, it shall be corrected.

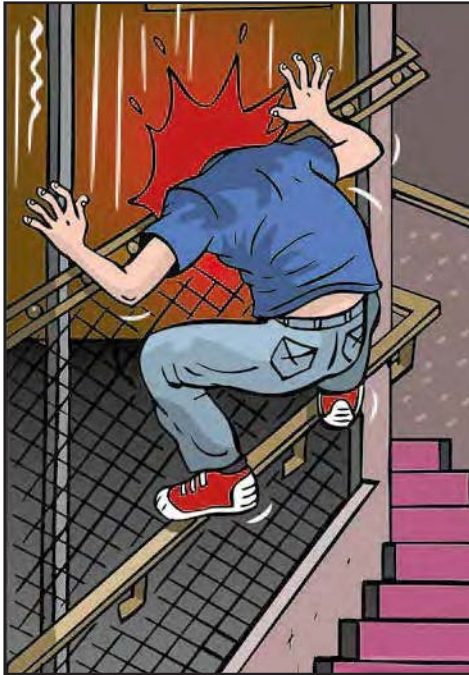
Well partially enclosed walls

Description of the risk

Objects, limbs or body parts are passed into the well, causing shearing and crushing of limbs, or even death. Lifts installed in a large staircase, where the stairs climb round the lift need to have full enclosures and no possibility for humans to put part of their body inside the shaft. Very silent lifts coming down at that moment can decapitate a person who would be looking down or calling down.

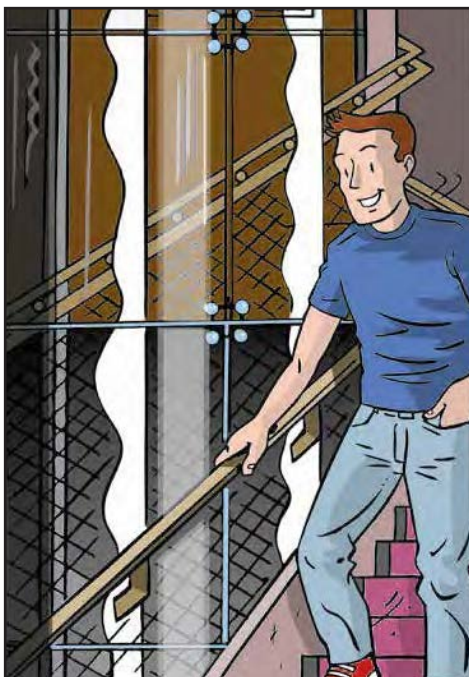
Risk reduction measures

The solution is a full enclosure, that can be done in the same wrought iron or wood material for example, but also plexy-glass or glass, making sure no animal (cat) or human can put its life at risk.

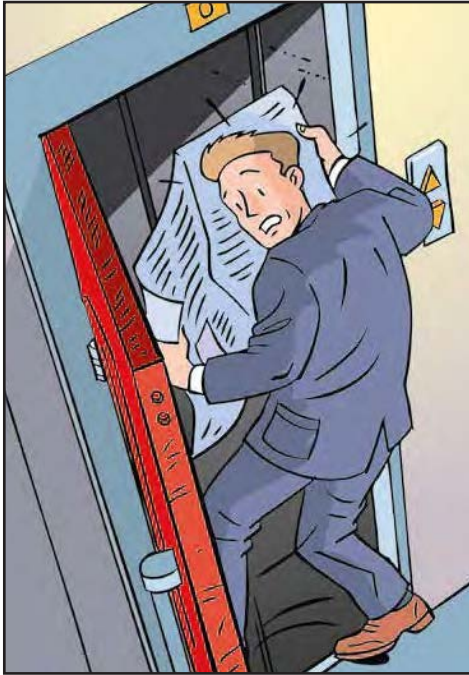
Unsafe locking device of landing door

Description of the risk

The landing door (swing door) is closed but not properly locked, the person is opening the door. no car is standing behind the door, the person falls down the well and is seriously hurt or killed.

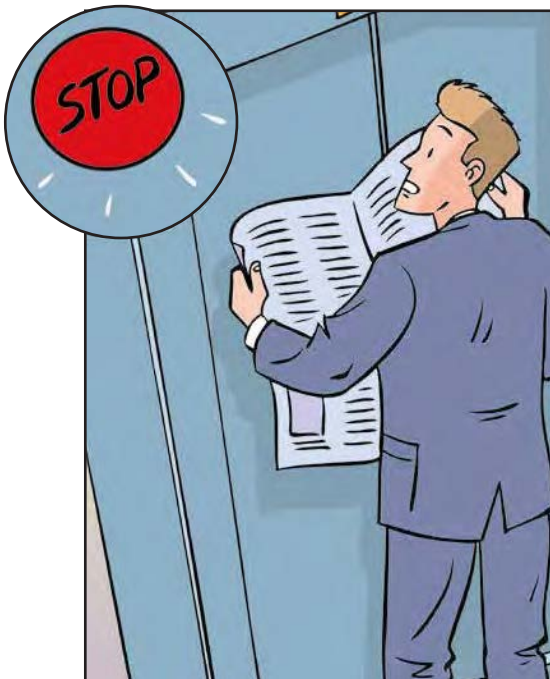
Risk reduction measures

The best way to prevent this type of accident is to install an adequate locking device on each landing door at every floor.

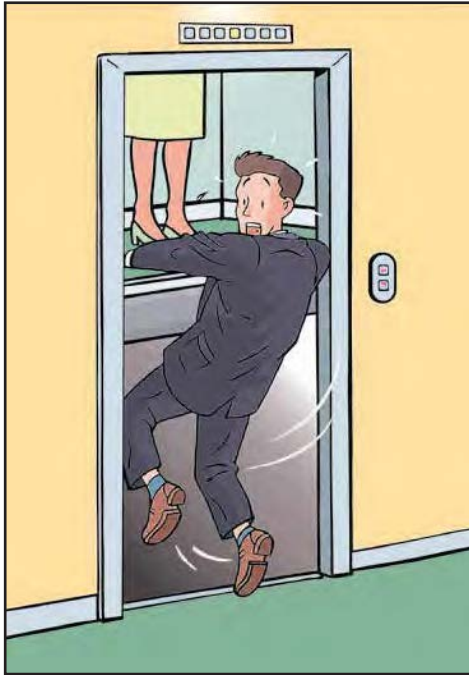
Inadequate length of car apron

Description of the risk

Rescuing trapped persons when a car is stopped above the landing. The person can fall down the well.

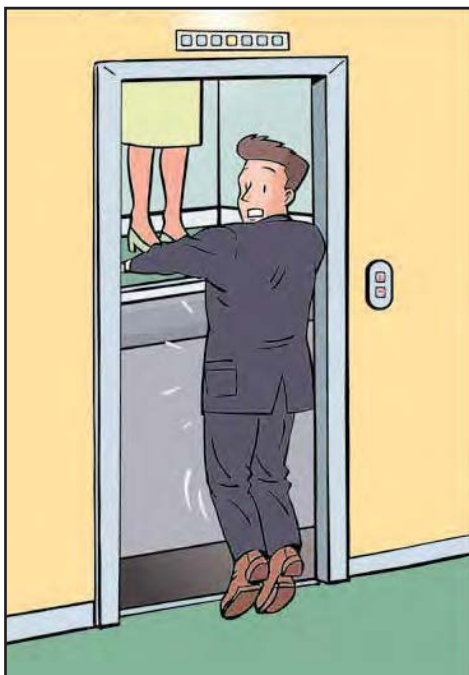
Risk reduction measures

An apron is positioned under the car. In case of stoppage of the car between 2 floors, if the passengers try to escape, climbing down on the landing, it often happens that they actually lose balance at the last second and fall in the shaft if the car apron is not long enough. The height of the vertical portion of the apron shall be at least 0,75 m.

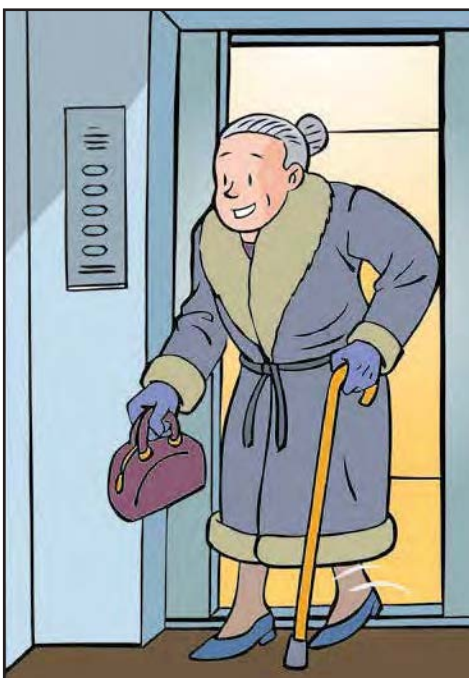
Risk reduction measures

Power operated doors must have an adequate protective closing device, detecting the presence of a body in the way and reopening after at most a light touch. For this purpose, sensitive light screens are to be installed.

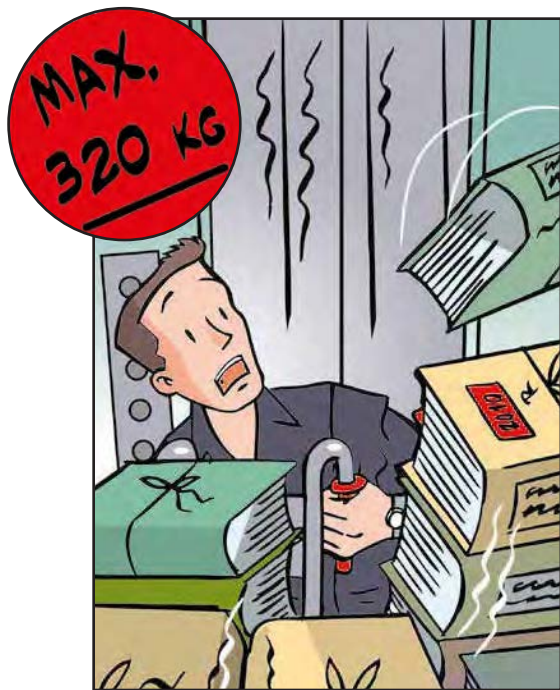
Large car area in relation to rated car load

Description of the risk

The lift is not used as intended, the car is overloaded with persons and/or load. The car slips away from the landing. Persons are sheared and crushed. Serious injuries.

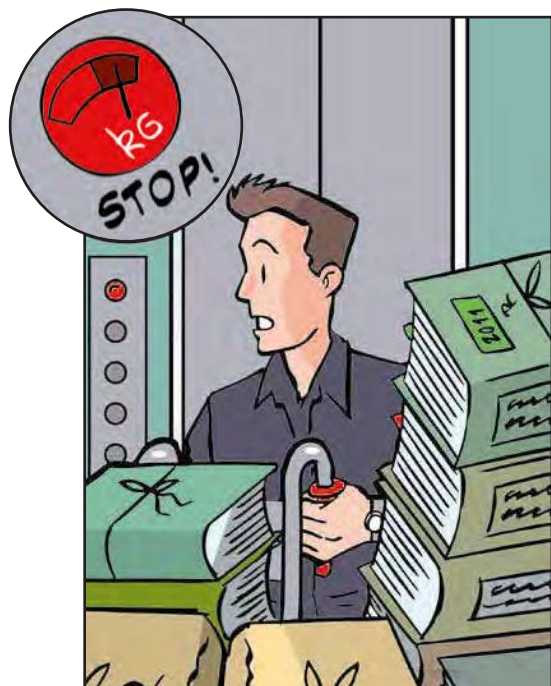
Risk reduction measures

To prevent an overloading of the car by persons, the available area of the car shall be limited. Furthermore a lift shall be fitted with a device to prevent normal starting, including re-levelling, in the event of overload in the car.

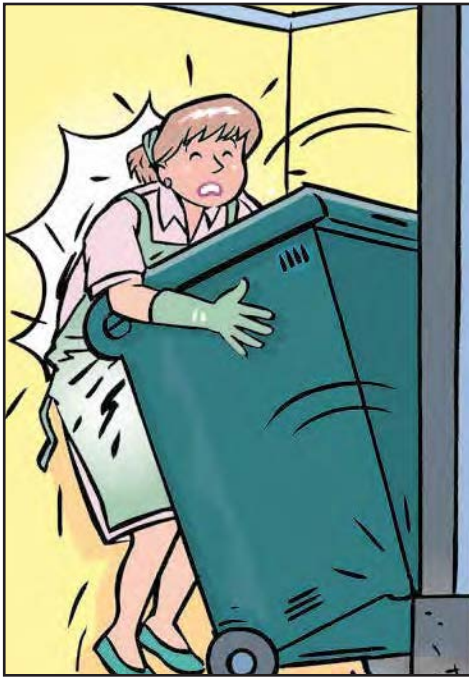
Description of the risk

Goods in the car hit the sill or recesses on the wall and tip suddenly. A child enters the gap between the car sill and the wall. Users are crushed, suffer serious injury or death.

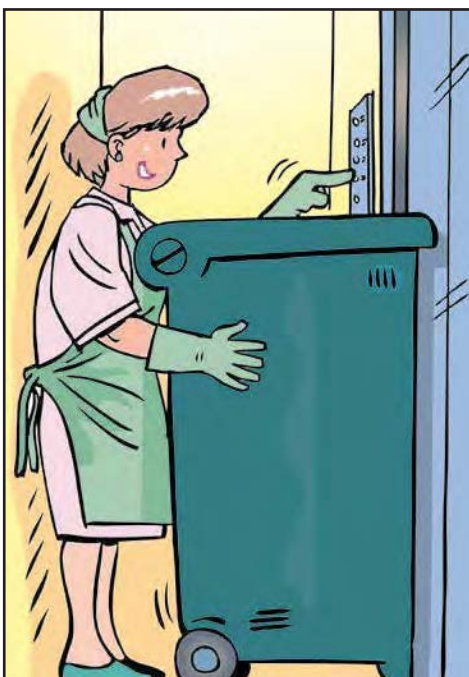
Risk reduction measures

Lifts must be equipped with car doors, protecting the users from contact with a moving surface.

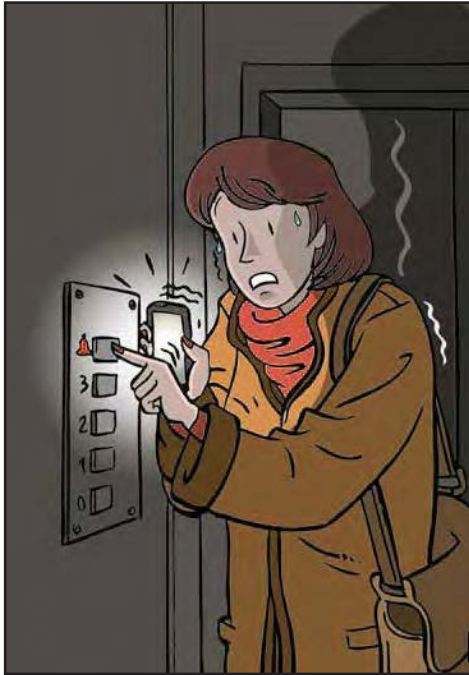
No or inadequate emergency light in car and on car roof

Description of the risk

In case of loss of power supply, a user does not always have a light source at hand in the lift. It is then difficult to find the right button to go up or down, or to call for assistance by pushing on the intercom button. Panic and claustrophobia can be the result.

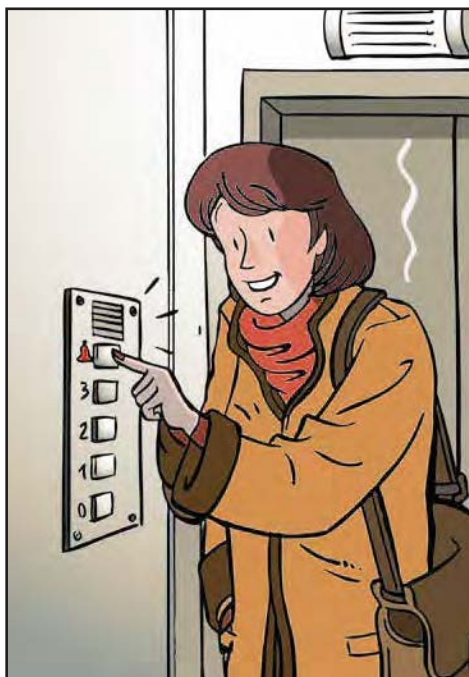
Risk reduction measures

All lifts should be equipped with emergency lighting in case of power failure, in the car and on the car roof as well.

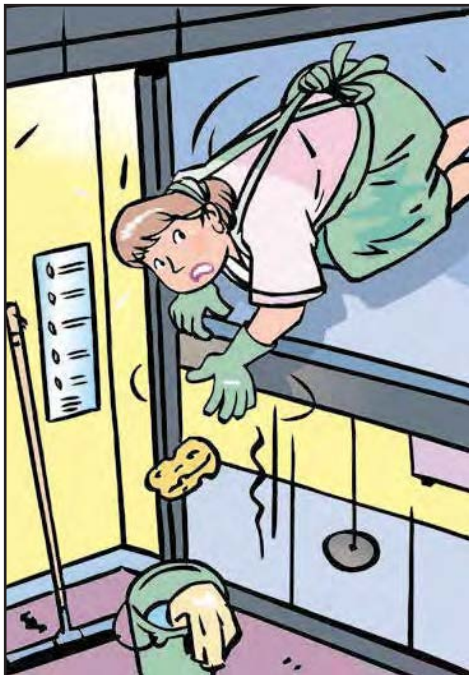
No or inadequate protection against free fall, overspeed and creeping on hydraulic lifts + no shut-off valve + no or inadequate low pressure device on hydraulic lifts

Description of the risk

The car leaves the landing with open door and creates a step between landing and cabin or moves away uncontrolled. Persons can fall in or out of the car as a consequence. There can be several causes: failure of suspension means, rupture of hydraulic piping, oil leakage, dirt impairing valve closing. note: if the car moves out of the door zone, the landing door closes automatically, so the big step disappears. Pipe rupture or leakage on hydraulic lifts can cause overspeed or “creeping” lifts, up or down . This surprises a person who is busy cleaning or passengers and creates dangerous situations if adequate safety devices are not installed.

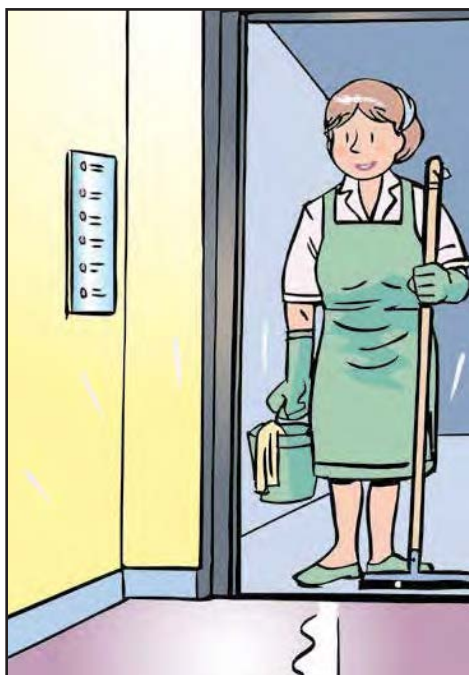
Risk reduction measures

A shut-off valve and a double safety combination of safety valves, safety gear and relevelling device must equip all lifts (uncontrolled movement and risk reduction measures).

A low pressure device avoids danger for passengers and equipment caused by the free fall of the car during emergency lowering (manual or electrical).

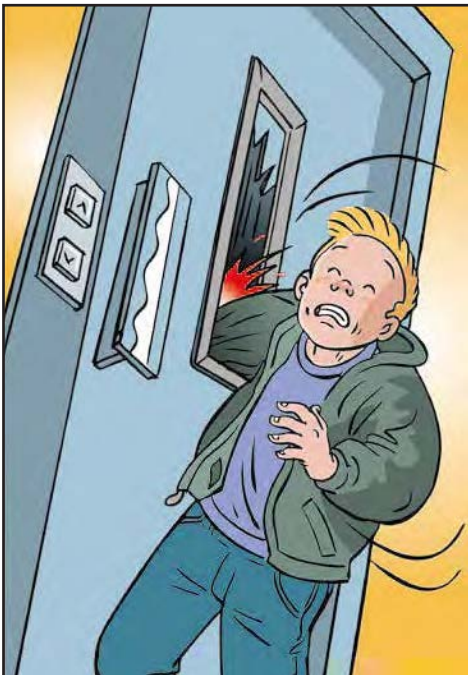
Inadequate glass in door

Description of the risk

If there is a glass panel in a lift landing or car door, it must be safety or armed glass, making it impossible for a person to break the glass by impact and to pass a limb or an object through the opening. It can lead to falling into the well, shearing of limbs, serious injury or even death.

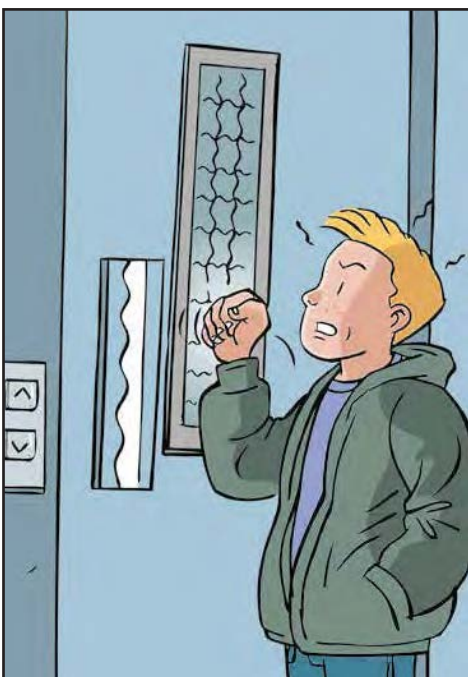
Risk reduction measures

All lifts with a glass panel in landing doors must be equipped with safety glass.

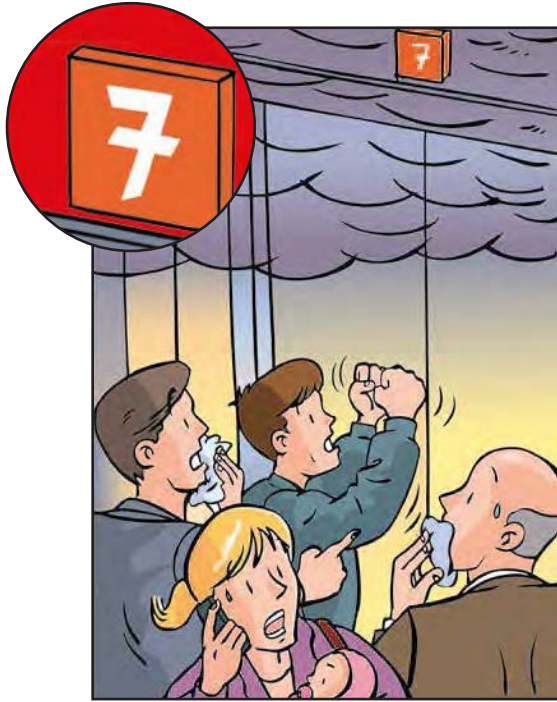
No or inadequate control functions in case of fire

Description of the risk

In case of fire and smoke detection, the lift must automatically go to the exit floor, open its doors and stay there with open doors. Firemen must have access to the building and have a key when they arrive on site, that enables them to take control of the lift. With that key, they can travel.

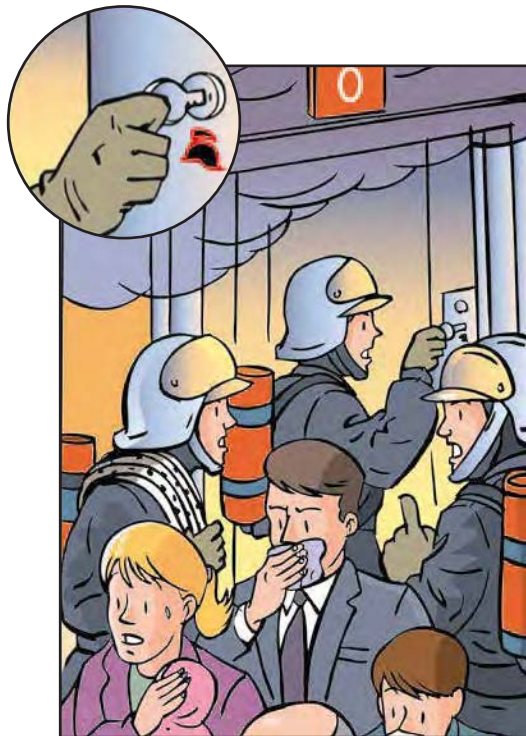
Risk reduction measures

All lifts must be equipped with safety functionalities, such as the automatic travel of the lift to the evacuation floor, and have a fireman key for access and control of the lift by the fire brigade in case of fire.

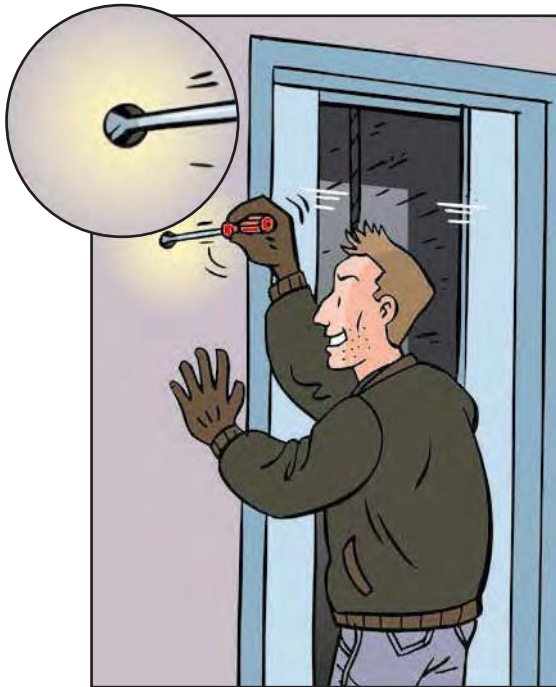
Inadequate locking devices on access doors to well and pit + unlocking of landing door without a special tool

Description of the risk

Non-authorized persons are entering the pit/well, and are crushed by moving parts.

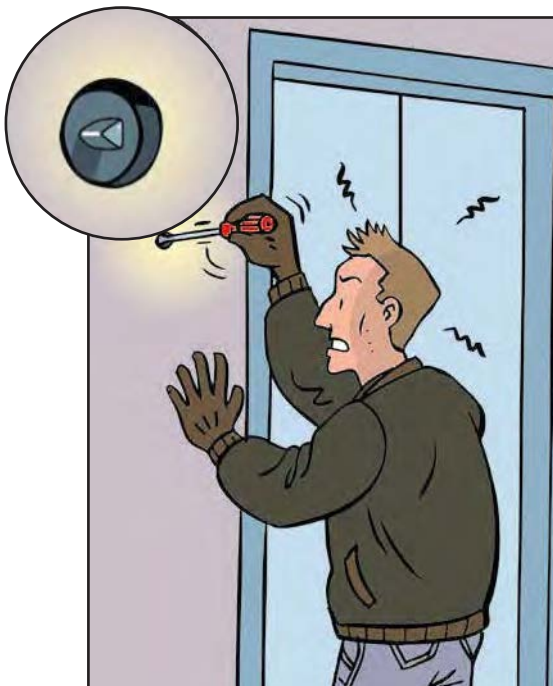
Risk reduction measures

In order to avoid vandals and thieves to fiddle with the key, the lock should be a triangular key, that is not available in shops and strongly restricts vandalism and opening of lift landing doors.

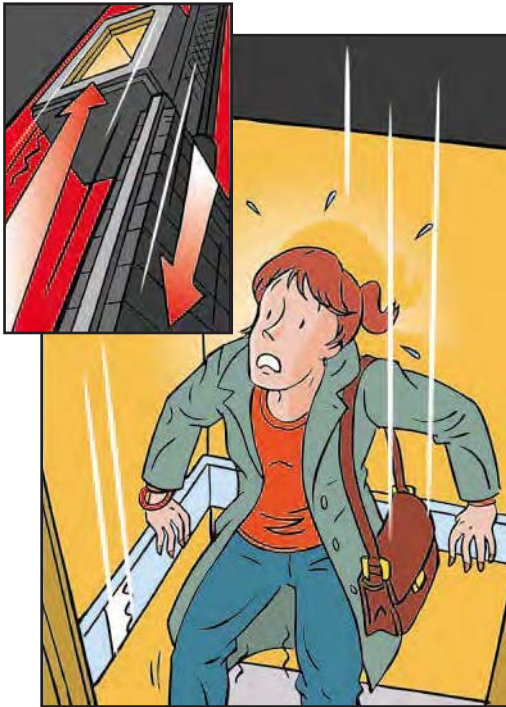
No protection means against ascending car overspeed on traction drive lifts with counterweight, no protection means against unintended car movement

Description of the risk

Overspeed in up direction due to failure of traction sheave shaft, brake failure, failure of electrical system, etc. The person in the car is injured when the car hits the roof of the well. The maintenance person is crushed on the car roof. If there is no protective means installed to avoid car overspeed in up direction, the lift may shoot up rapidly and crash against the ceiling of the shaft.

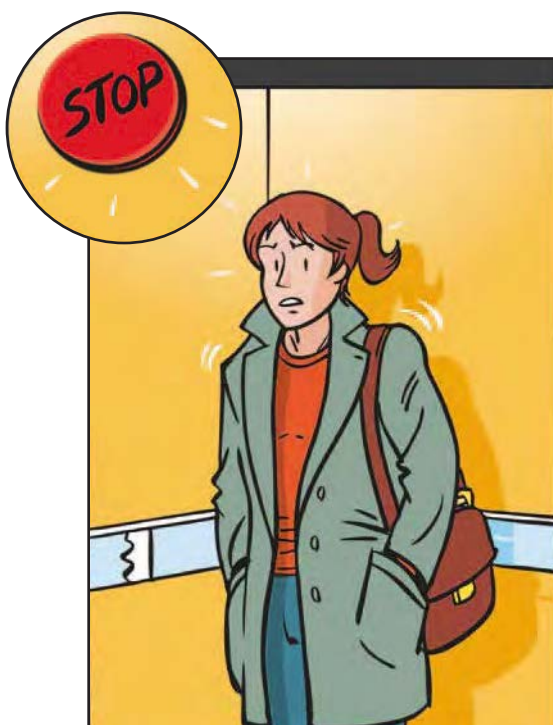
Risk reduction measures

All traction drive lifts should be equipped with the necessary upward overspeed protective means.

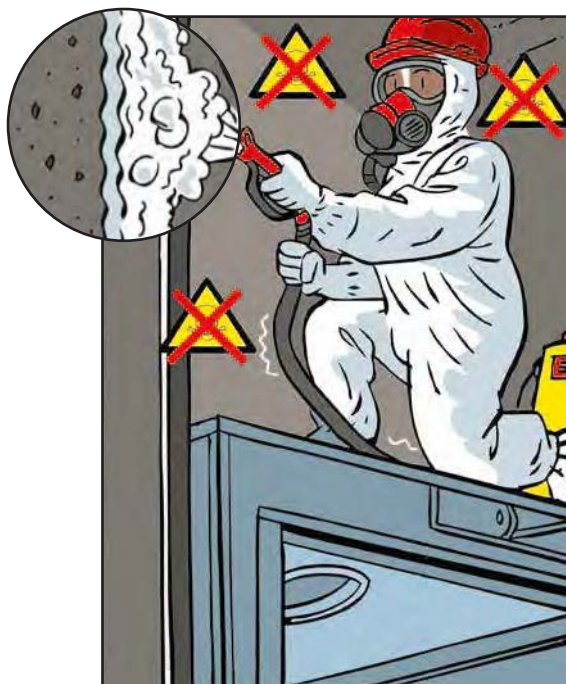
The technicians or inspectors (and possibly users) are exposed to harmful materials, due to wear, ageing, repair or modernization work. Asbestos is particularly harmful today in the building as it was used as insulation on walls and in cavities. The mechanic can inadvertently drill into it and create dangerous dust, which can cause a fatal lung disease much later in time.

The owner of the building has to eradicate asbestos and other materials from the building, and hire specialist teams that remove it completely or like here, put a special film over the asbestos covered surfaces with stickers indicating that there is asbestos behind the film. Existing asbestos brake lining must be replaced with asbestos free brakes.

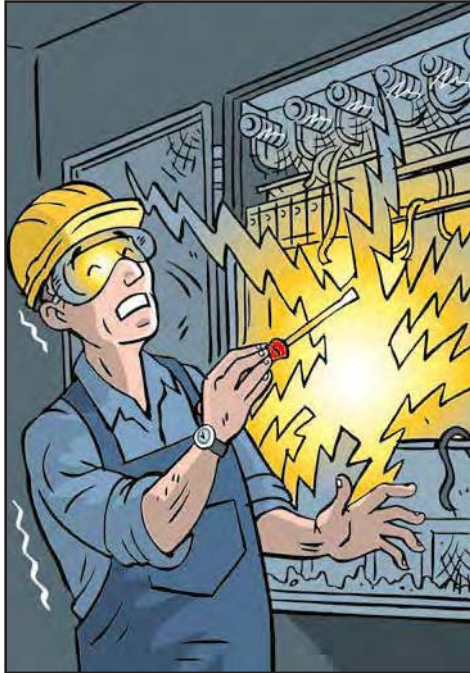
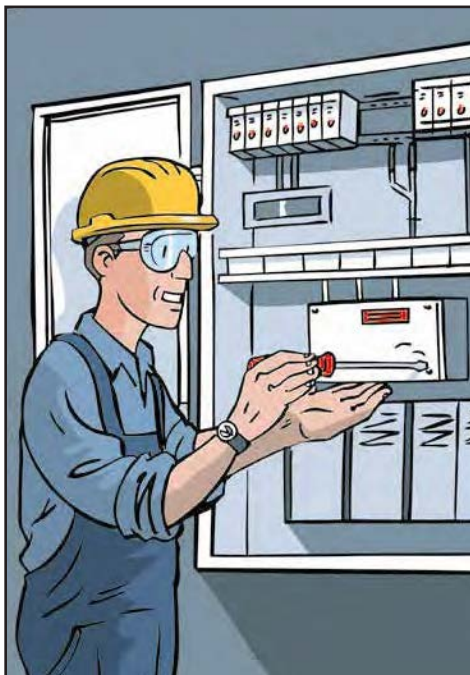
Insufficient protection against electric shock and/or marking of electrical equipment; missing notices

For workers, the electric distribution board can be old and the wiring dangerous to work on or even approach.

All electrical connections and wiring should be state-of-the-art.

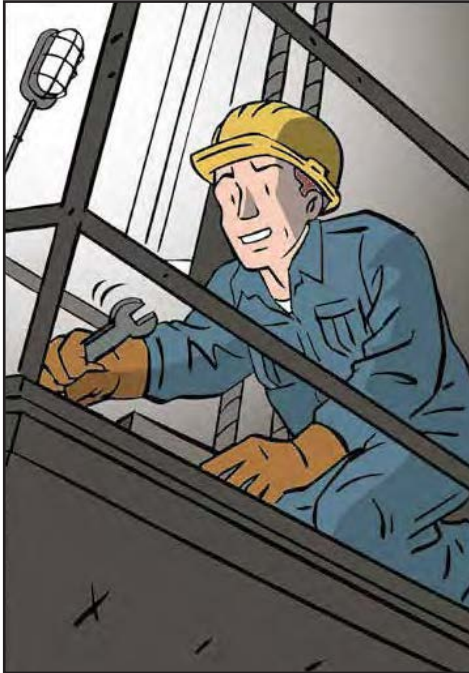
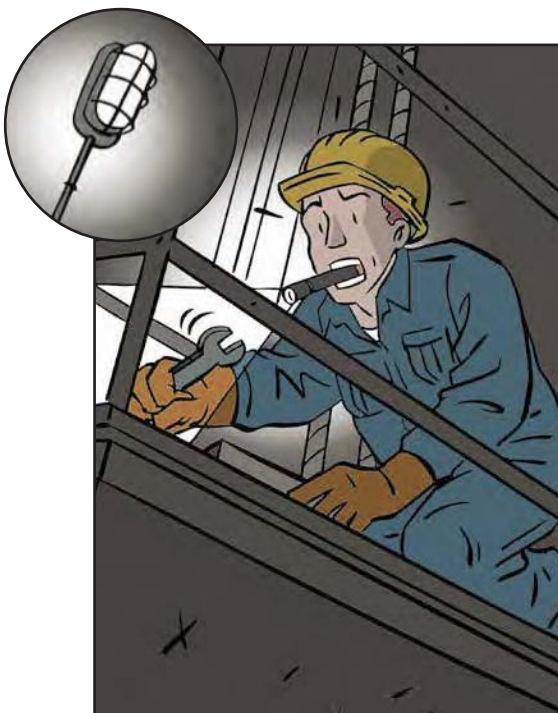
No or inadequate lighting of the well or inadequate lighting in machine or pulley room

The lift well is a working area for technicians and inspectors and can be a dangerous space to work in if not correctly lit.

The pulley/machine room and the shaft will be lit with a light that can be switched off when not needed.

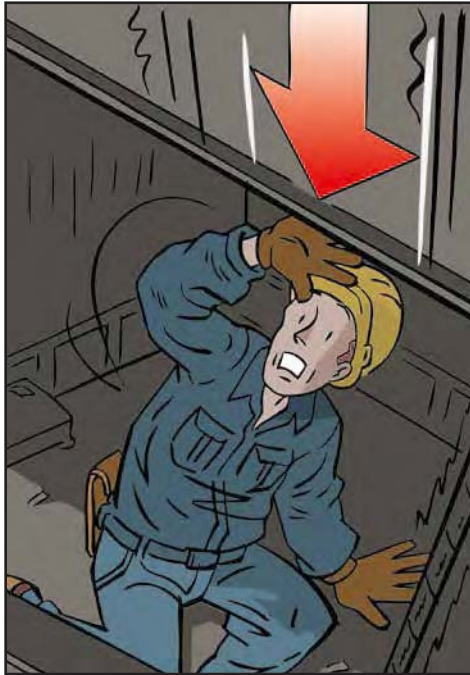
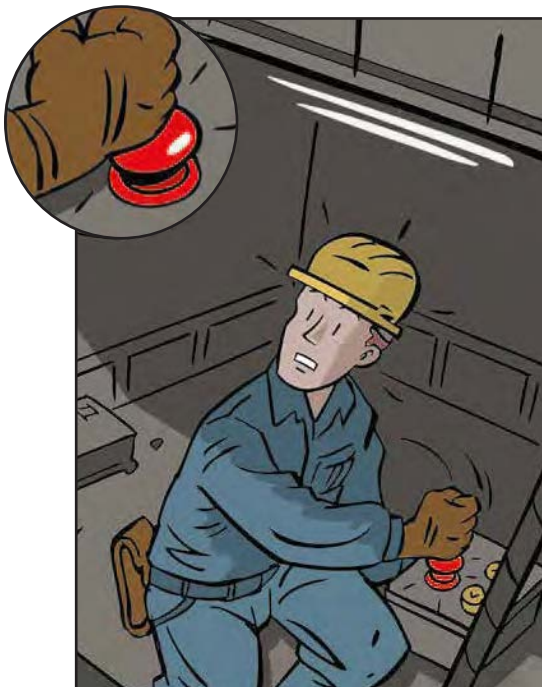
Insufficient safety spaces in headroom and in pit. No inspection device in pit.

Mechanics and lift inspectors can be crushed between the top of the car and the shaft ceiling or in the pit, if there is not sufficient pit and head room to hold him/them in a standing, crouched or lying position.

Mechanics in pit are exposed to the risk of crushing when someone is working on car roof and makes the car move by inspection control.

There should be enough room on top of the car and in the pit when the lift is in extreme positions (actual space or at least space created by other means). There should be a stop button on the car roof and in the pit, including also an inspection box on the car roof and in pit. The car is allowed to move by inspection when there are mechanics in the pit by the simultaneous pushing on the same direction buttons of both inspection control units.

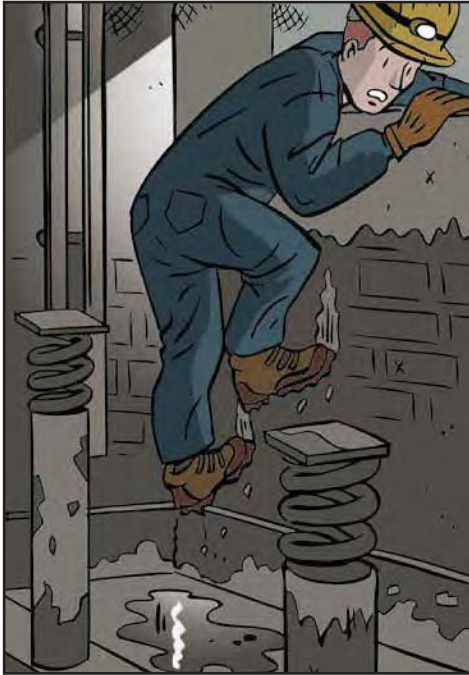
Inadequate vertical surface below landing door sills + unsafe pit access

Pit access, pit walls and bottom can be in a very bad condition, with litter filling the pit, oil or liquid residues, the absence of a ladder, risk of fall from height, no lighting, etc... and no communication.

The pit shall be clean, dry, the walls in good condition, a ladder provided and an intercom button with microphone must be put in the pit, to allow a trapped mechanic to call and request help (portable phones may not work in pits, shafts and confined spaces in general).

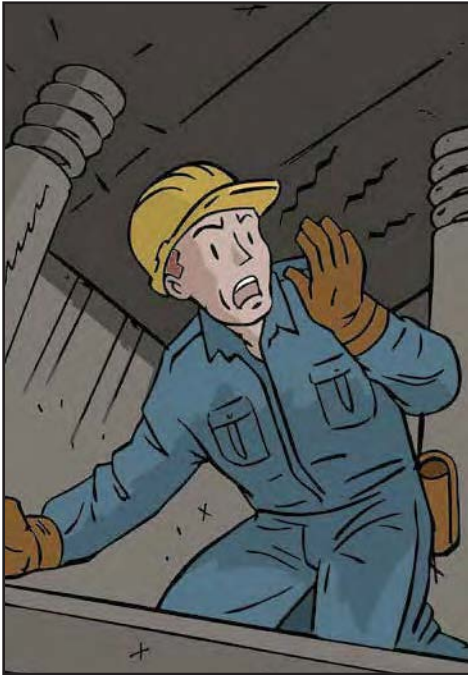
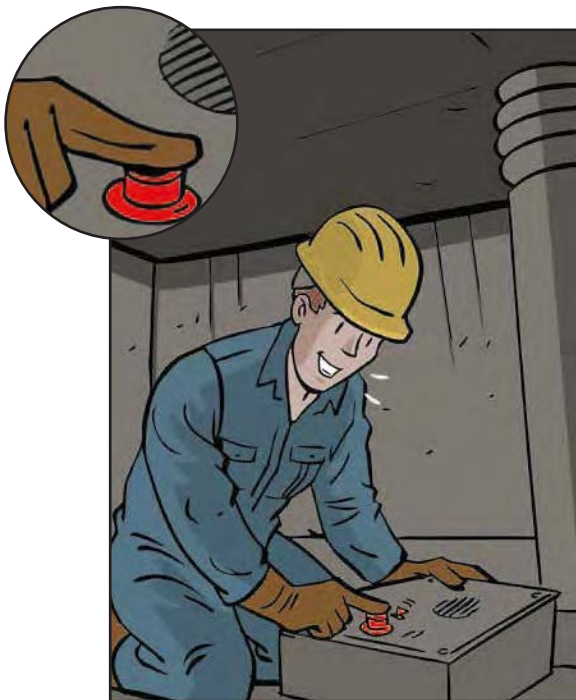
A person is trapped or injured in the pit or on the car. If there is no alarm system in the pit or on the car roof, rescue and treatment of injury cannot reach the mechanic in time. It can lead to serious injury.

Install adequate alarm system in the pit and on the car roof.

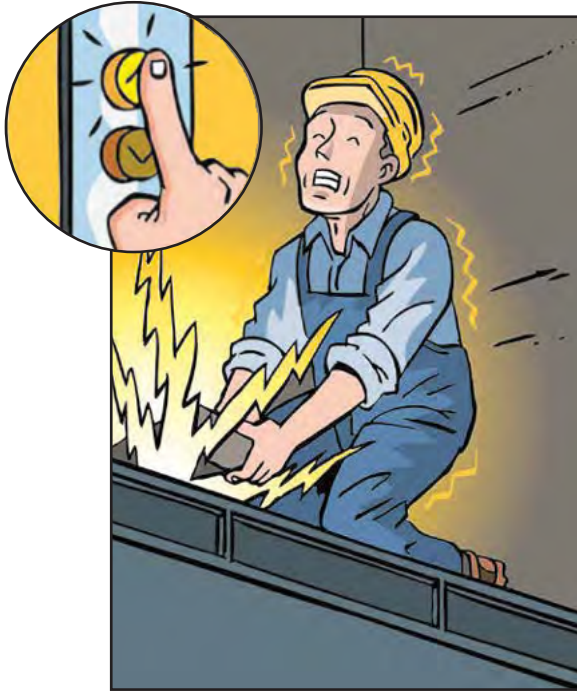
No lockable main switch

A person switches the lift on when another person is working on the lift. Result: the maintenance/inspection person is sheared or crushed. Injury to users or workers can take place, for example electric shock or unintended car move that can harm the mechanic working in the well.

The main switch must be lockable by the mechanic when he works on the lift.

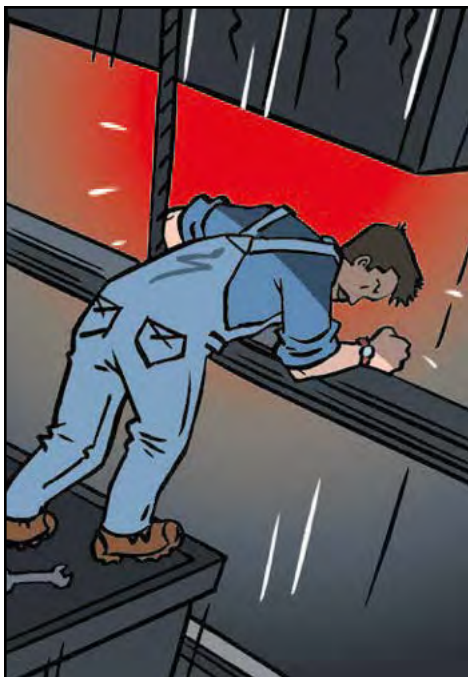
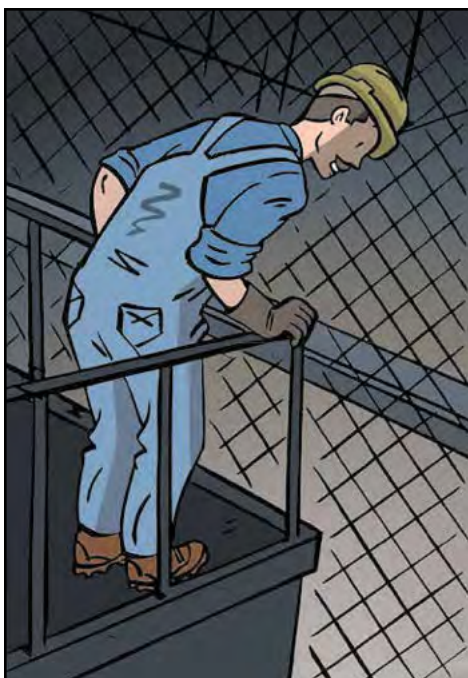
No or inadequate partition of counterweight/balancing weight travel path + no or inadequate pit screen for several lifts in the same well + no or inadequate balustrade on car

The mechanic working in a shaft with multiple lifts can be hit by the car or a moving part of another lift than the one he is working on. He can also fall in the shaft if there is no balustrade, harness system and/or adequate partition.

If there are two or more lifts in the same well, balustrade and partitions must be installed where necessary. The technician must be protected from falling by a balustrade.
